TECHNICAL REPORT HL-87-7

BANK PROTECTION, BASS LOCATION WILLAMETTE RIVER, OREGON

Hydraulic Model Investigation

Hydraulics Laboratory

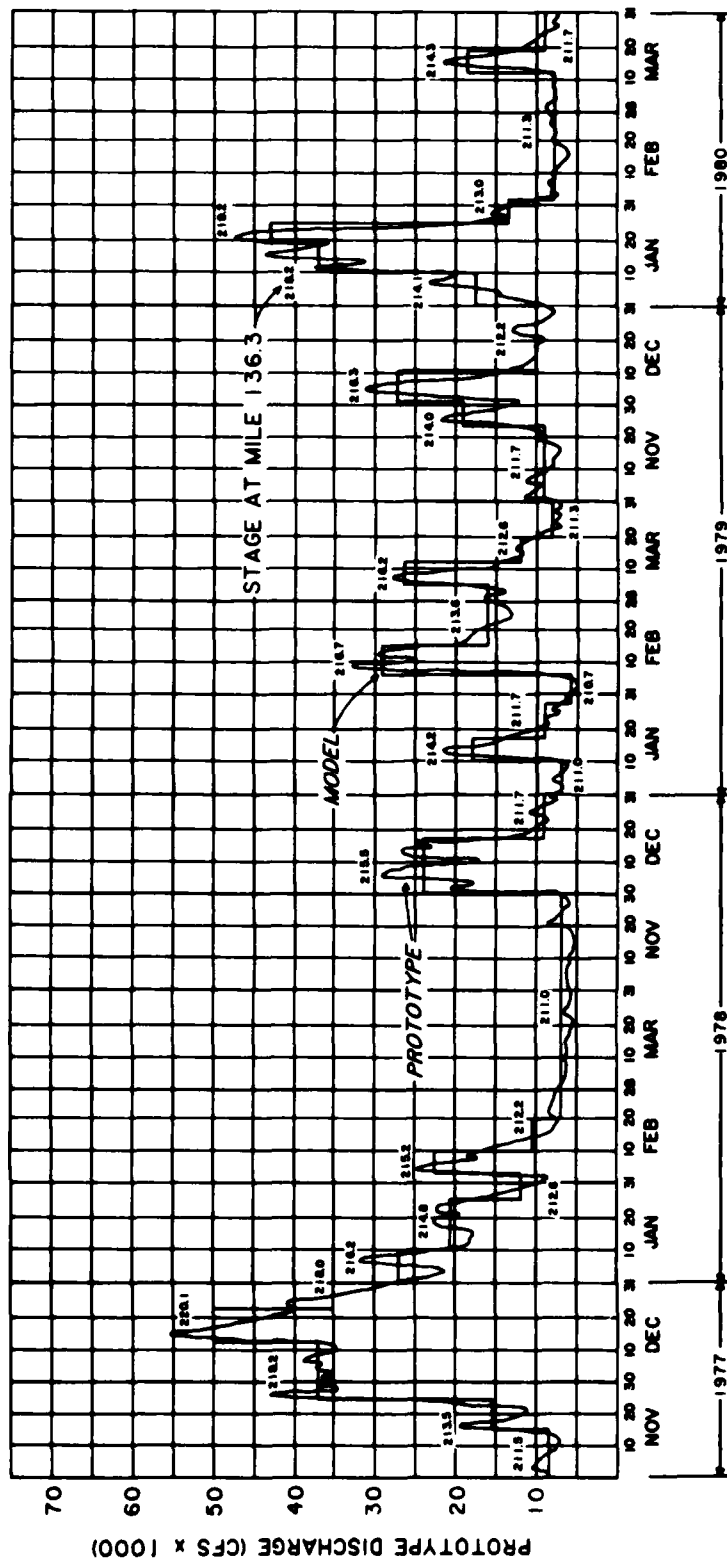
MODEL ADJUSTMENT AND 2-YEAR-FREQUENCY HIGH-WATER MONTHS HYDROGRAPH

NOTE: NUMBERS INDICATE STAGE
ELEVATION IN FEET NGVD

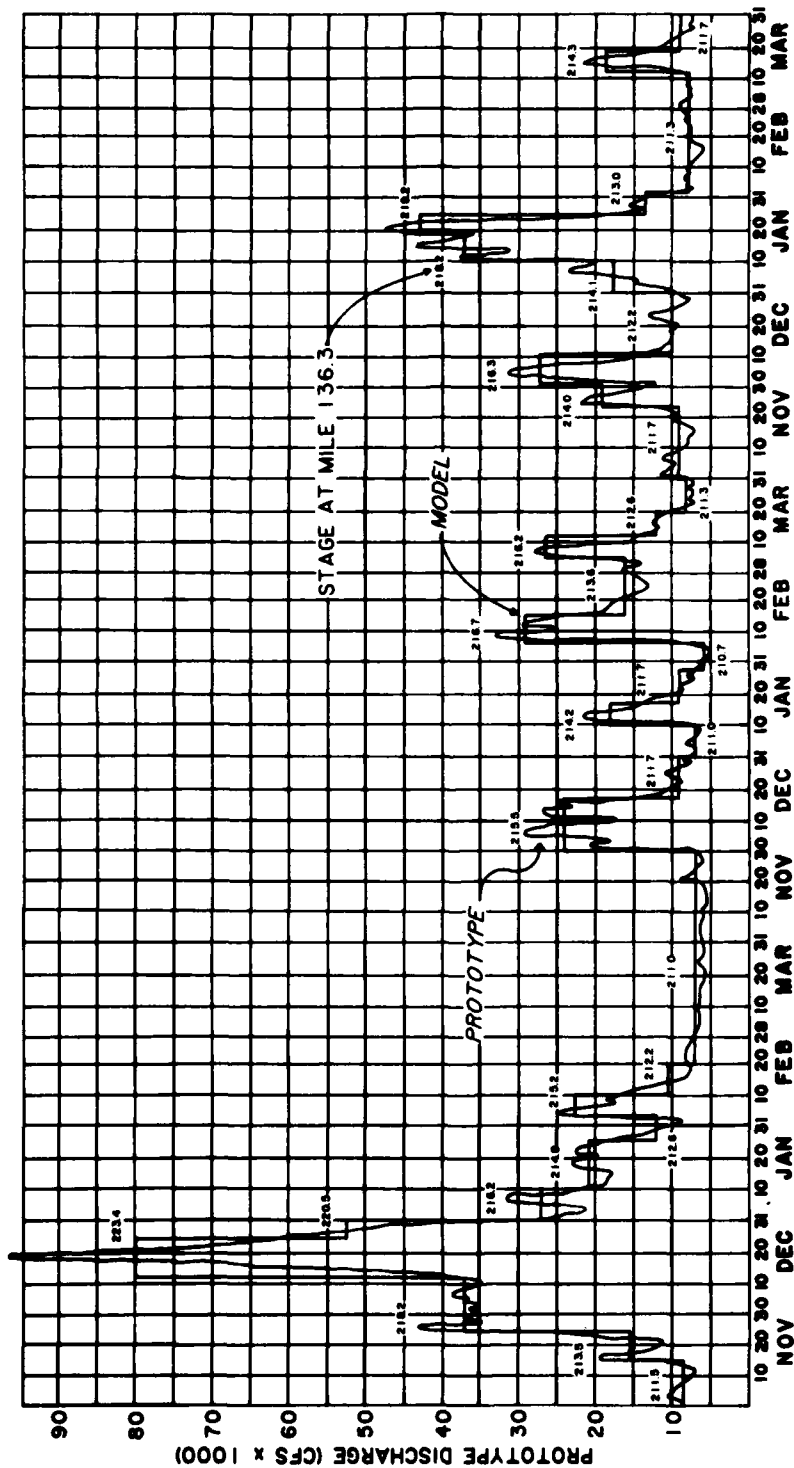
25-YEAR-FREQUENCY HIGH- WATER MONTHS HYDROGRAPH

NOTE: NUMBERS INDICATE STAGE
ELEVATION IN FEET NGVD
